## HDSL2 DDM+ H2TU-C

P/N 1223003L2  
CLEI: T113AERA\_\_

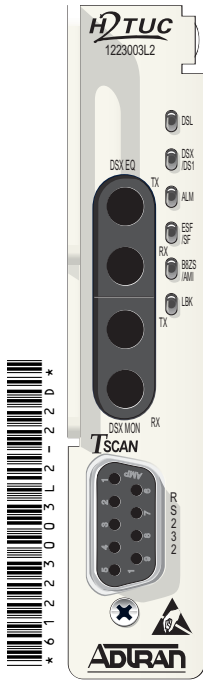
### FRONT PANEL LEDES

<b>DSL</b>	<span style="color: green;">●</span> Green	DSL sync, no errors currently detected, and signal margin > 2 dB
	<span style="color: red;">●</span> Red	No DSL sync, errors being detected, or signal margin ≤ 2 dB
<b>DSX/DS1</b>	<span style="color: green;">●</span> Green	DSX-1 signal is present and no errors currently being detected
	<span style="color: red;">●</span> Red	No DSX-1 signal or signal is present with errors
<b>ALM</b>	<input type="radio"/> Off	No active alarm present
	<span style="color: red;">●</span> Red	Loss of DSX-1 signal to the unit
	<span style="color: yellow;">●</span> Yellow	Loss of DS1 signal to the remote
<b>ESF/SF</b>	<input type="radio"/> Off	Unit is provisioned for UNFRAMED data
	<span style="color: green;">●</span> Green	Unit is provisioned for SF data
	<span style="color: yellow;">●</span> Yellow	Unit is provisioned for ESF data
<b>B8ZS/AMI</b>	<span style="color: green;">●</span> Green	Unit is provisioned for AMI line code

<span style="color: yellow;">●</span> Yellow	Unit is provisioned for B8ZS line code
<b>LBK</b>	<input type="radio"/> Off	Unit is <b>not</b> in loopback
	<span style="color: yellow;">●</span> Yellow	Unit is in loopback (network and/or customer)
