Upgrading Firmware on an ADTRAN Netvanta 160 Series Unit in Recovery Mode

When an ADTRAN Netvanta 160 series access point (AP) is in need of firmware, it will enter a mode called “Recovery.” Recovery mode is similar to “Bootstrap” mode in AOS. The Recovery state can be viewed from the Command Line Interface (CLI) or the Web Interface, both shown below.

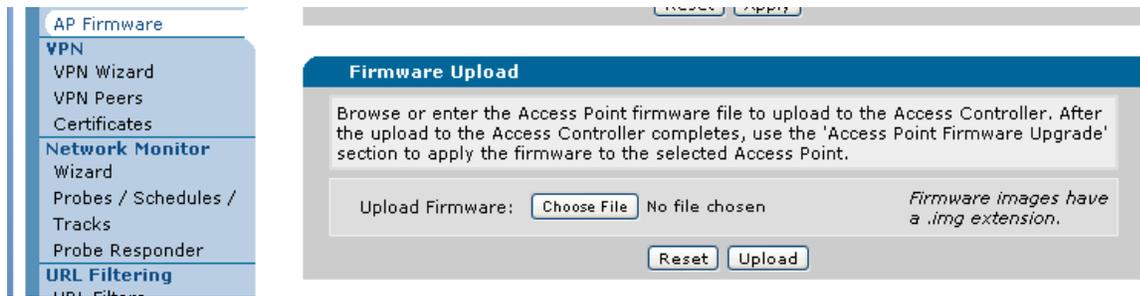
If you are going to use the AOS access controller as the TFTP server, you can upload an image on the same page in the Firmware Image section:

In this case, when you fill out the Access Point Firmware Upgrade section, use the IP address for the controller (the interface that is in the same subnet as your AP) as the TFTP server IP address. This automatically enables the TFTP server on your unit so it does not need to be manually enabled prior to initiating the upgrade.
